# Manhole Inspection Summary

Manhole # S43C\_\_004MH

Insp Date: **4/13/08 11:49 AM**

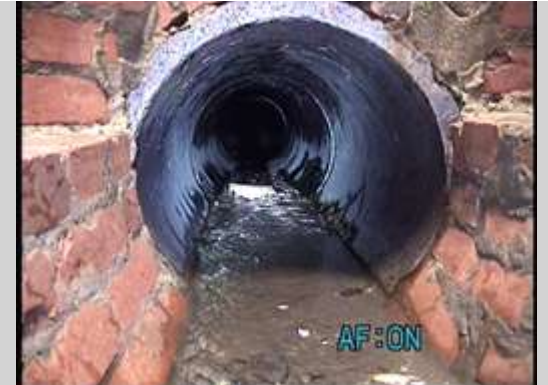
12 O'Clock Outflow

12 in. Circular Gravity Sewer  
Pipe Out @ 12 O'Clock

Pipe Height: **13.2** (in.) Rod and Bar (Angled)  
Pipe Material: **Clay** ☐ Pipe Lined  
Invert Depth: **7.60** (ft.) Flow Characteristics: **Slow**  
Deposits: ☒ None ☐ Mud ☐ Sludge ☐ Debris ☐ Grease  
Silt Depth: (in.) Deposits Extent:  
Infiltration: **None** Pipe Seal Cond: **Sound**

Drop: **None**

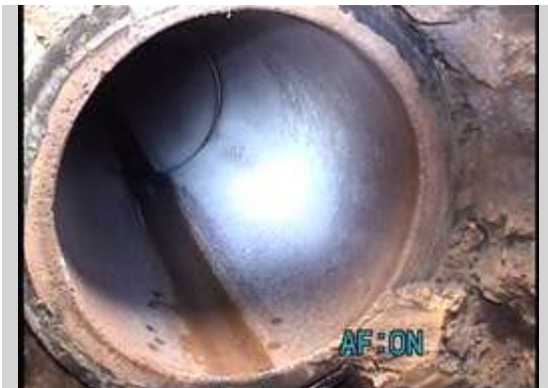
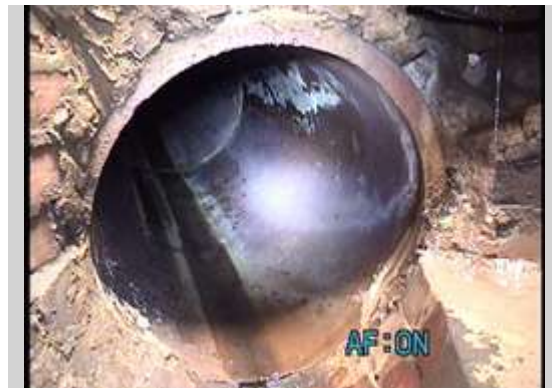
4 O'Clock Inflow

12 in. Circular Gravity Sewer  
Pipe In @ 4 O'Clock

Drop In @ 4 O'Clock

Pipe Height: **13.2** (in.) Rod and Bar (Angled)  
Pipe Material: **Clay** ☐ Pipe Lined  
Invert Depth: **5.30** (ft.) Flow Characteristics: **Slow**  
Deposits: ☒ None ☐ Mud ☐ Sludge ☐ Debris ☐ Grease  
Silt Depth: (in.) Deposits Extent:  
Infiltration: **None** Pipe Seal Cond: **Sound**

Drop: **Outside** Rod and Bar  
Angled: **Yes** Reading: **6.00** (ft.)  
Inv Depth: **7.00** (ft.)

Drop Condition: **Open**

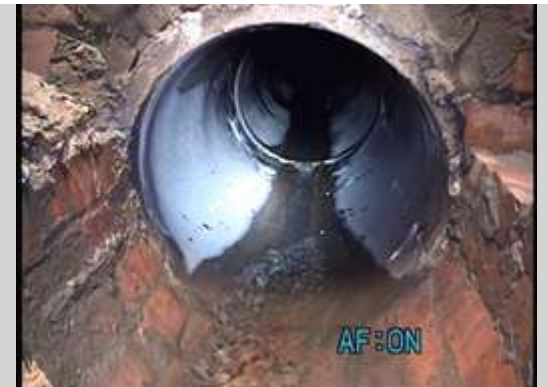
6 O'Clock Inflow

18 in. Circular Gravity Sewer

Pipe In @ 6 O'Clock

Pipe Height: **18** (in.) Rod and Bar (Angled)

Infiltration: **None**

Pipe Seal Cond: **Sound**

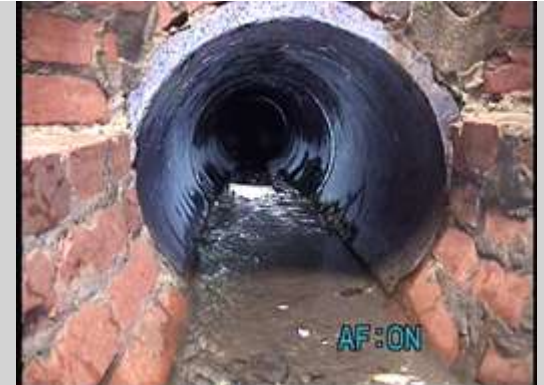
12 O'Clock Outflow

12 in. Circular Gravity Sewer  
Pipe Out @ 12 O'Clock

Pipe Height: **13.2** (in.) Rod and Bar (Angled)  
Pipe Material: **Clay** ☐ Pipe Lined  
Invert Depth: **7.60** (ft.) Flow Characteristics: **Slow**  
Deposits: ☒ None ☐ Mud ☐ Sludge ☐ Debris ☐ Grease  
Silt Depth: (in.) Deposits Extent:  
Infiltration: **None** Pipe Seal Cond: **Sound**

Drop: **None**

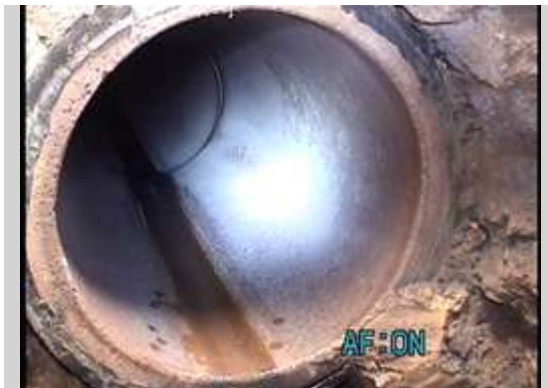
4 O'Clock Inflow

12 in. Circular Gravity Sewer  
Pipe In @ 4 O'Clock

Pipe Height: **13.2** (in.) Rod and Bar (Angled)  
Pipe Material: **Clay** ☐ Pipe Lined  
Invert Depth: **5.30** (ft.) Flow Characteristics: **Slow**  
Deposits: ☒ None ☐ Mud ☐ Sludge ☐ Debris ☐ Grease  
Silt Depth: (in.) Deposits Extent:  
Infiltration: **None** Pipe Seal Cond: **Sound**

Drop In @ 4 O'Clock

Drop: **Outside** Rod and Bar  
Angled: **Yes** Reading: **6.00** (ft.)  
Inv Depth: **7.00** (ft.)  
Drop Condition: **Open**

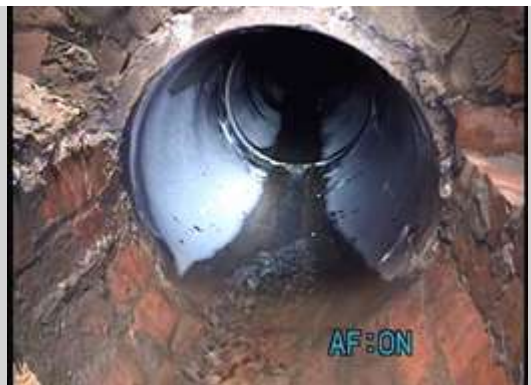
6 O'Clock Inflow

18 in. Circular Gravity Sewer  
Pipe In @ 6 O'Clock

Pipe Height: **18** (in.) Rod and Bar (Angled)

Infiltration: **None**
